ATTACHMENT 9 HYDROLOGY MONITORING REPORT

ALBANY BUSH LANDFILL Hydrologic & Water Quality Monitoring Schedule – April 17, 2007

Albany Bush Landfill - culverts (092606 site visit)

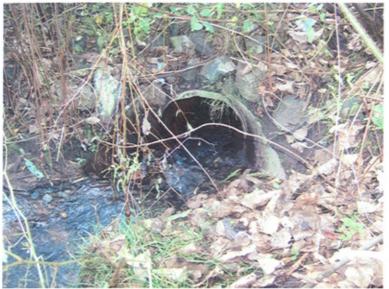
Culvert 1

2-15" CMP pipes under Rapp Road

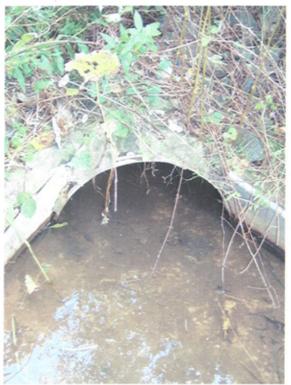
Culvert 2

24" CMP with bottom 8' sediment covered

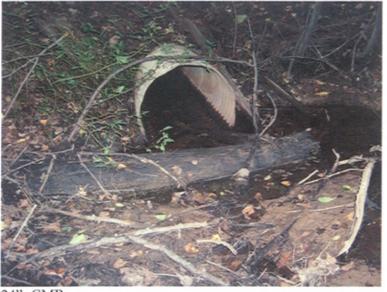
Culvert 3

24" CMP

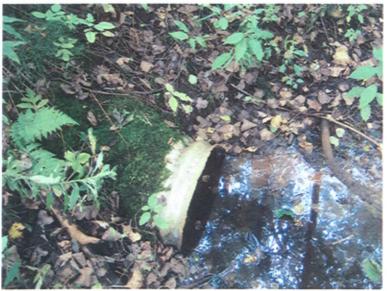
Culvert 5

24" CMP

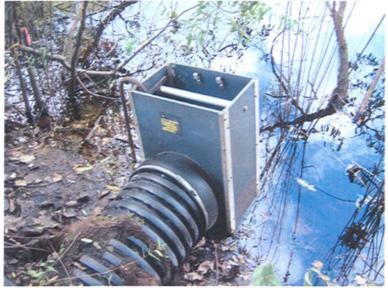
No picture or data Culvert 7

10x16 rectangular riser (10" above outlet top) discharging through 12" plastic corrugated pipe
